#### DOT/FAA/CT-97/7

# A Field Study of Transponder Performance in General Aviation Aircraft

Nicholas J. Talotta

**Final Report**

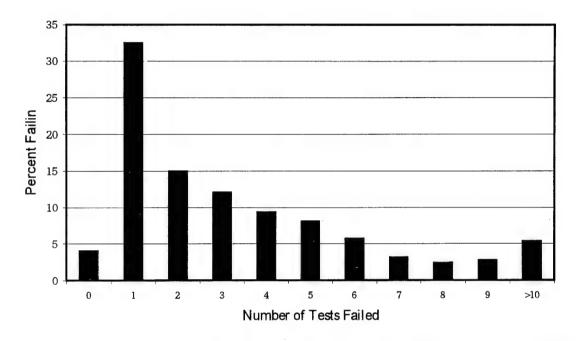
FIGURE 3. PERCENT OF TRANSPONDERS THAT FAILED TESTS

Figure 3 presents an overall picture of the number of tests that were failed by the combined transponder sample. As indicated by the figure, only 4 percent of the transponders succeeded in meeting the performance criteria on all of the 31 tests, while approximately 6 percent failed more than 10 of the tests. The average transponder failed just over three tests.

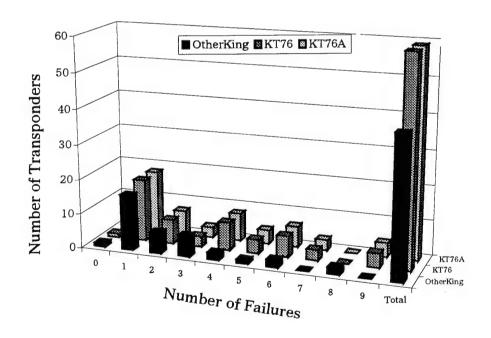
FIGURE 4. KING TRANSPONDER FAILURES

Figure 4 is a histogram of the number of test failures accumulated by three model groups of King transponders. The data show that the average KT76A model tended to have fewer test failures than the earlier KT76 design (typically from one to four). Almost one-half of the KT76A units had only one failure. This single failure typically occurred on the Suppression Rejection parameter that is probably attributable to a design characteristic of the KT76A.

The KT76 model normally failed from two to eight parameter tests. The transponder group labeled "other" was composed of a small group of newer King models and tended to have fewer failures than the KT76A.

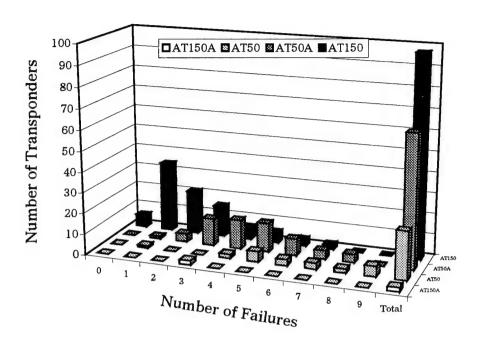
FIGURE 5. NARCO TRANSPONDER FAILURES

Figure 5 summarizes the failure data for the Narco transponders. The sample group was primarily composed of three models: the AT 150 (97), the AT 50A (64), and the AT 50 (43). The pattern of test performance for the Narco models was similar to the King models with newer designs failing fewer tests. The AT 150 units appeared to fail the smallest number of tests (0 to 4). The AT 50A typically failed from two to eight tests. The AT 50 normally failed more than five tests. There were only two AT 150A models. One of these failed two and the other four tests.

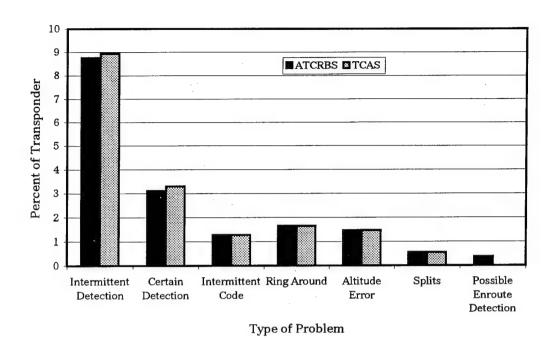
FIGURE 6. OPERATIONALLY SIGNIFICANT TRANSPONDER FAILURES

Figure 6 summarizes the results of the analysis. The graph presents the percentage of sample aircraft that would create significant operational problems for the ATCRBS processor and TCAS. The problems are divided into the seven failure categories described below.

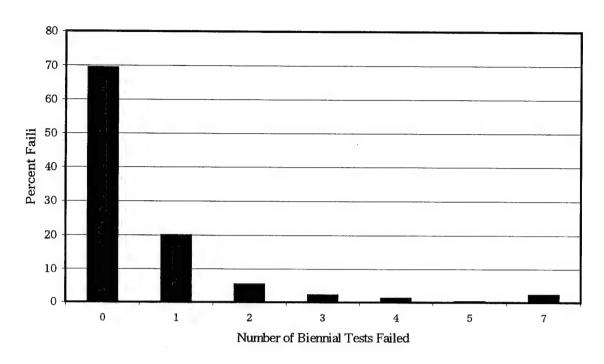
FIGURE 7. NUMBER OF FAILURES ON THE BIENNIAL INSPECTION TESTS

A secondary objective of this study was to determine the implications of the results for mandatory periodic transponder inspection requirements. Currently, FAR Part 43 requires that all transponders be tested every 2 years to insure that they are within specifications on 7 of the 31 performance parameters assessed during the study (see table 1). Figure 7 presents the percentage of transponders that failed from zero to all seven of the biennial tests. These data show that 69 percent of the total transponder sample passed all of the required tests. Approximately 19 percent failed one of the tests. The transponders that failed all seven tests were those that did not work at all.

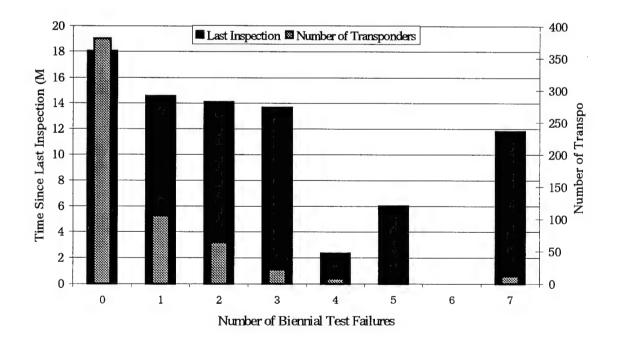
FIGURE 8. BIENNIAL TEST FAILURES AS A FUNCTION OF TIME SINCE LAST INSPECTION

transponder in the sample had received its last inspection 16 months prior to testing in this study. As shown in the figure, transponders with no failures averaged 18 months since the last inspection, while those failing all tests averaged 12 months.

The sample sizes for those failing four, five, and seven tests were small in comparison to those that failed from one to three tests. Nevertheless, the findings suggest that time, since the last inspection, is not a good predictor of the number of biennial tests that a transponder will fail. This apparent lack of association between the recency of biennial inspection and transponder performance was confirmed by statistical testing. A coefficient of correlation computed between inspection date and test failures for each of the transponders in the total sample yielded a Spearman's r value of -.04, indicating a complete lack of relationship between these two variables.

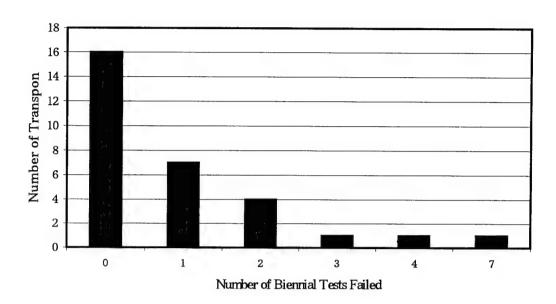
FIGURE 9. NUMBER OF BIENNIAL TEST FAILURES FOR 30 CANADIAN AIRCRAFT

However, it is noteworthy that of these 30 aircraft, eight had failures sufficient to cause problems with existing ATCRBS and TCAS systems. Of the eight failures, one transponder did not work at all, three will have intermittent detection problems with existing systems, two will have intermittent code problems, one will have an altitude error, and one will create "ring around."

Despite these failures, for those Canadian aircraft that reported an inspection date, there was no correlation between biennial test performance and time since last inspection (r = .02).
